Mikuni MKII Post Repair

I recently bought a '78 XS750SE Special that hadn't been run for several years. When I put gas in it, it immediately poured out of the airbox, so I knew it was time to rebuild the carbs. Someone had obviously been there before me, and in the process had broken a float post, then tried to repair it by epoxying the pin to the post. I suppose this might have worked (it didn't), so I decided to repair it properly. Here's how I did it with normal shop tools and a little patience-

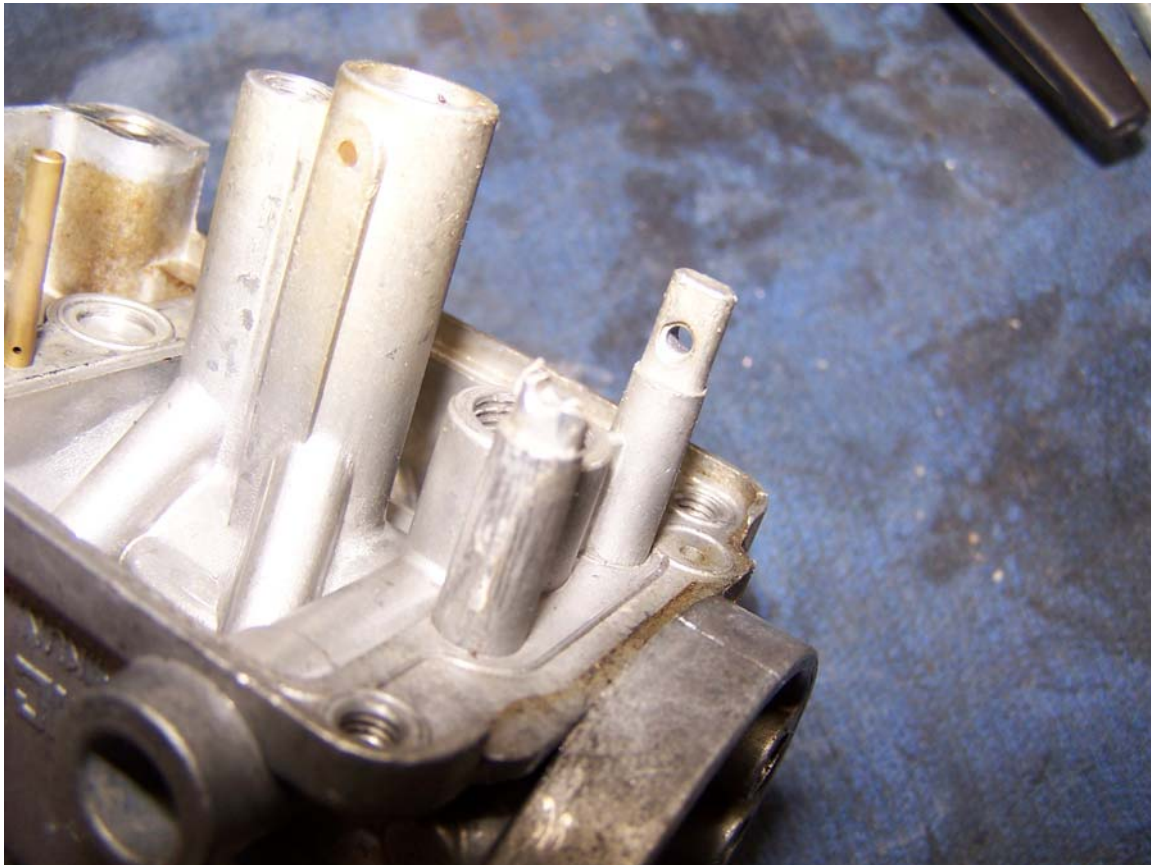
This photo shows the broken post –
